ASTM F1642-04/GSA TS01/UFC 4-010-01 TEST REPORT

Report No.: C4837.03-801-12

PRODUCT TYPE: Horizontal Sliding Window SERIES/MODEL: 8200

SPECIFICATION: ASTM F 1642-04, Standard Test Method for Glazing and Glazing Systems Subject to Airblast Loading.

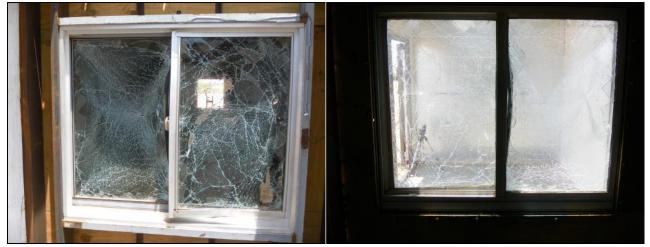
Glazing Response		
Lite	Fixed	Operable
Exterior Lite	Fractured	Fractured
Interior Lite	Fractured	Fractured
Glazing Pullout Length and Location	79"	None
Glazing Tearing	1.75" at center	None

A dusting of glass was deposited on the witness chamber floor. The glazing generally fell between zero and 40" of the inside face of the glazing. One (1) fragment was located at 112". Two (2) glazing sliver perforations were located below 20" on the vertical witness panel.

Photo No. 3 Post-test, Interior

Photo No. 4 Post-test, Exterior

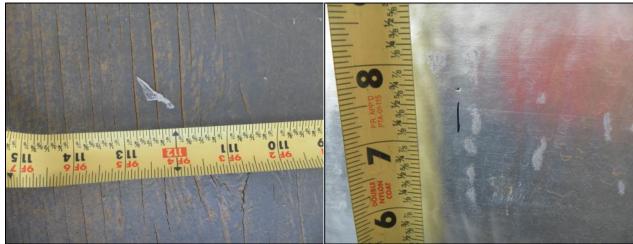
Photo No. 5 Post-test, Fragment

Photo No. 6 Post-test, Witness Panel Impact

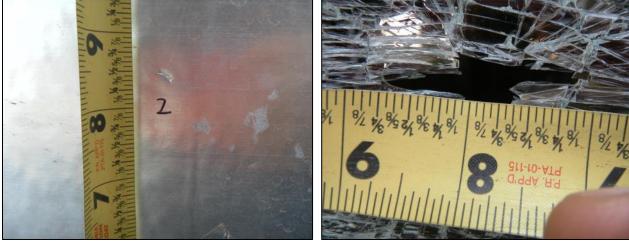
Photo No. 7 Post-test, Witness Panel Impact

Photo No. 8 Post-test, Glazing Tear

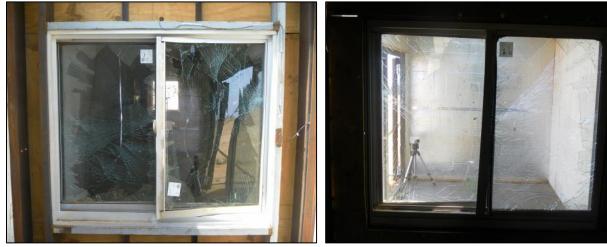
A dusting of glass was deposited on the witness chamber floor. The glazing generally fell between zero and 40" of the inside face of the glazing. One (1) fragment was located at 58". Zero (0) perforations or indents were located on the vertical witness panel.

Photo No. 5 Post-test, Fragment
