**H0258.03-303-11-R1
ACOUSTICAL PERFORMANCE TEST REPORT
ASTM E90**

Series/Model: 487-AR

Type: Office Partition

Acoustical Performance Test Report

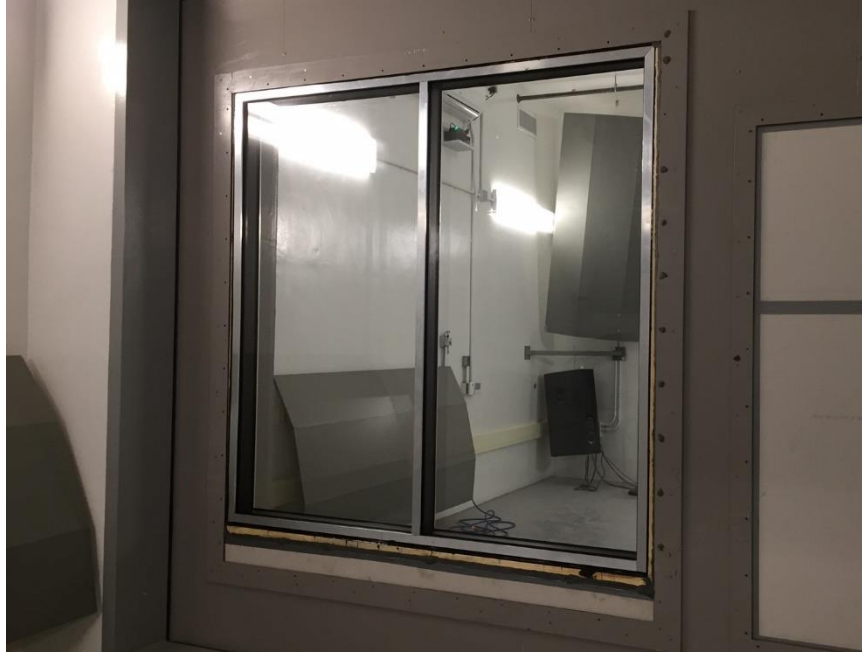
Receive Room View of Installed Specimen

A sound transmission loss test was initially performed on a filler wall. The specimen plug was removed from the filler wall assembly. The specimen was placed on a foam isolation pad in the test opening. Duct seal was used to seal the perimeter of the specimen to the test opening on both sides. The interior side of the specimen, when installed, was approximately 1/4" from being flush with the receive room side of the filler wall. A stethoscope was used to check for any abnormal air leaks around the test specimen prior to testing. Operable portions of the test specimen, if any, were cycled at least five times prior to testing.

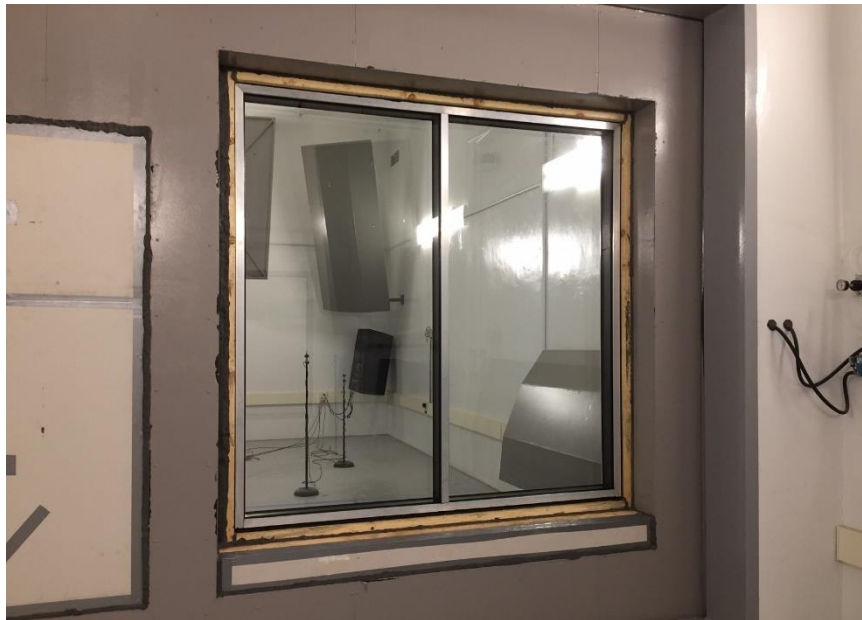
Source Room View of Installed Specimen
