TEST REPORT

Report No.: H2466.07-801-44

PRODUCT TYPE: Aluminum Side Hinged Single Door
SERIES/MODEL: 500TC Thermal Composite Door

Title	
	500TC Single Door
Design Pressure	±2400 Pa (±50 psf)
Air Infiltration	.55 L/s/m ² (0.11 cfm/ft ²) @ 75 Pa (1.57psf)
Air Infiltration	2.4 L/s/m ² (0.47 cfm/ft ²) @ 75 Pa (6.24psf)

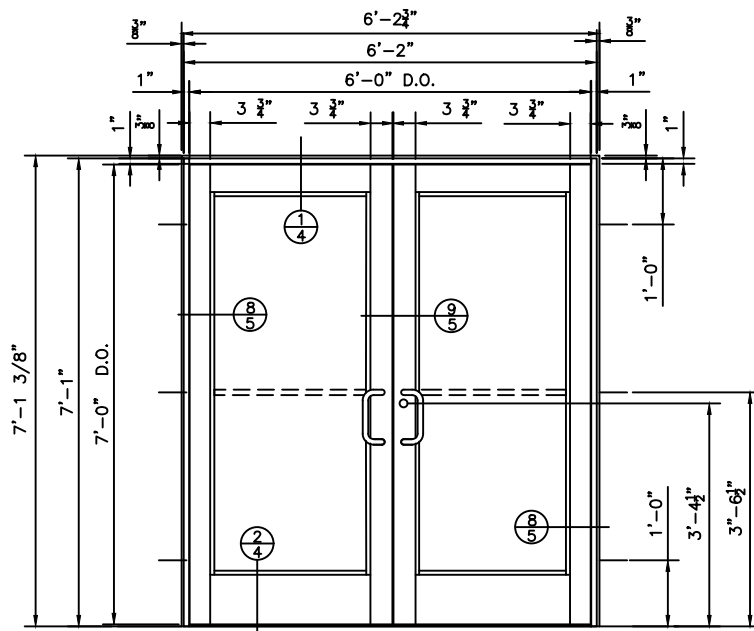
Test #1

Test #1: Pair Door	1.57 psf Air Test	50psf design	75psf structural	Forced Entry
Test #2 Single Door	1.57 psf & 6.24PSF Air Test	50psf design	75psf structural	Forced Entry

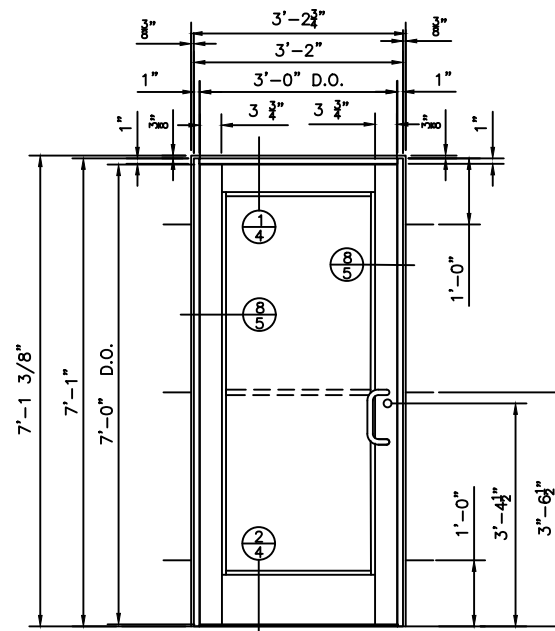
Test #2

Door Hardware Test # 2		
Qty:	Hardware #:	Description:
1 Set	OP-6, OP-7, OP-9, OP-10, OP-11	Offset Pivots
1	DH22900	1-1/2" Back Set Hook Bolt Lock
1	375TLC	Cylinder Kit
	PR032/PR034	Push/Pull
	375TG159	Bulb Gasket-Door Stops

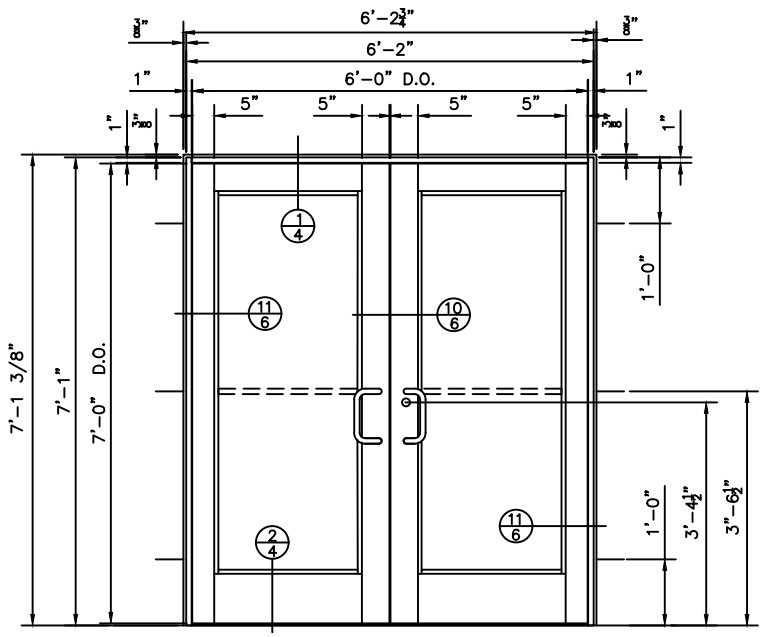
Test #3

Test #3: Pair Door	1.57 psf Air Test	50psf design	75psf structural	Forced Entry
Test #4 Single Door	1.57 psf & 6.24 Air Test	50psf design	75psf structural	Forced Entry

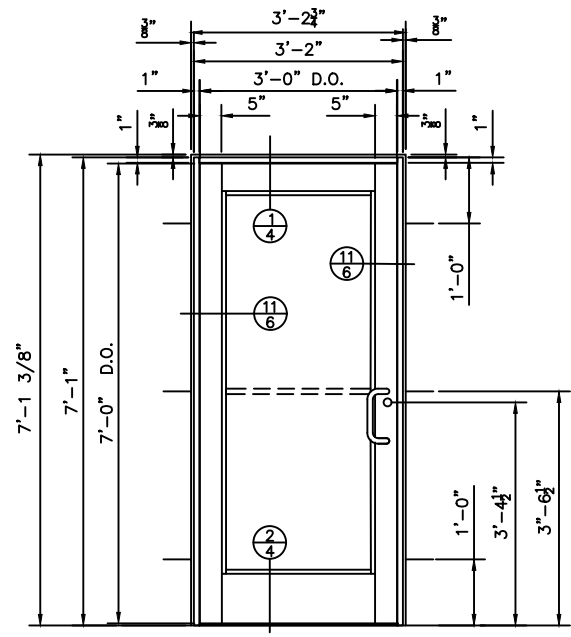
Test #4

Door Hardware Test # 4		
Qty:	Hardware #:	Description:
1 Set	OP-6, OP-7, OP-9, OP-10, OP-11	Offset Pivots
1	DH22900	1-1/2" Back Set Hook Bolt Lock
1	375TLC	Cylinder Kit
	PR032/PR034	Push/Pull
	375TG159	Bulb Gasket-Door Stops
